Fiat 500 Service Schedule Additional Procedure

Please be aware that within the scheduled servicing operations there has been added a specific check procedure for checking the condition of the front brake hoses on Fiat 500.

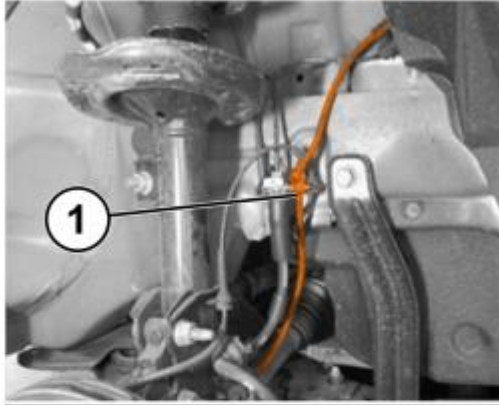
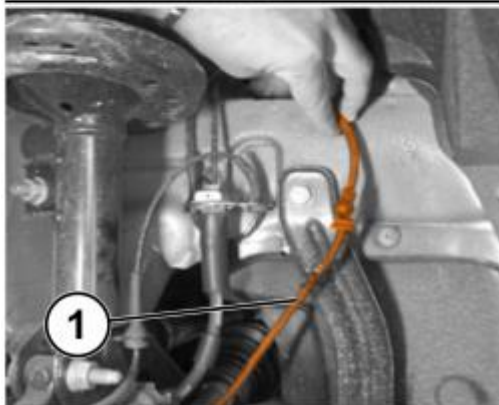
1. Remove the brake pad wear sensor wiring (if any) from the housing.

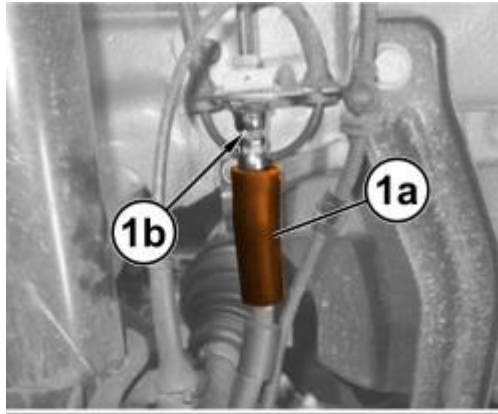
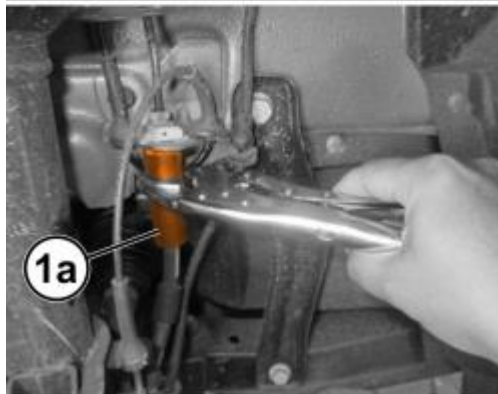
1. Move the rubber protection (1a) away until the connection (1b) of the brake hose line is completely uncovered.

If necessary, use a suitable vice to facilitate the release of the protection

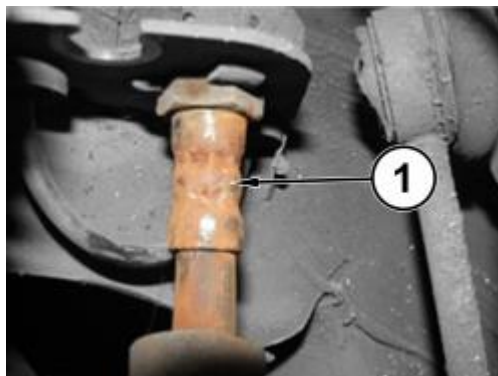
- Clean the fitting using "SOCOSAT A2501" wipes (or equivalent product).
- Blow compressed air onto the surface. Examine the brake hose connection.

3. If there is rust and the connector is NOT damaged, proceed as follows:- Apply the "LOCTITE SF 7500" anti-rust agent (or equivalent product) using a suitable brush, taking care to apply it also to the rear part of the fitting.- Wait 20 minutes for the product to dry and then restore rubber protection.

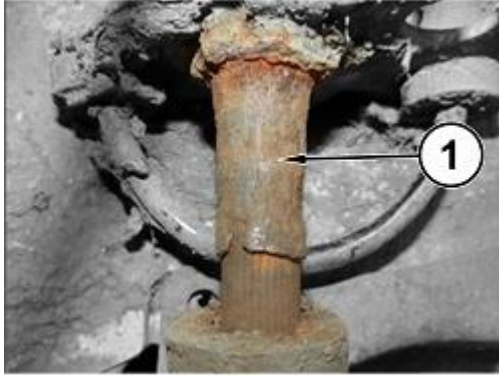
4. In case of rust and or damage to the fitting, replace the hose as described in the relevant procedure.
